# Experimental and numerical analyses of a deep foundation containing a single defective pile

## Abstract

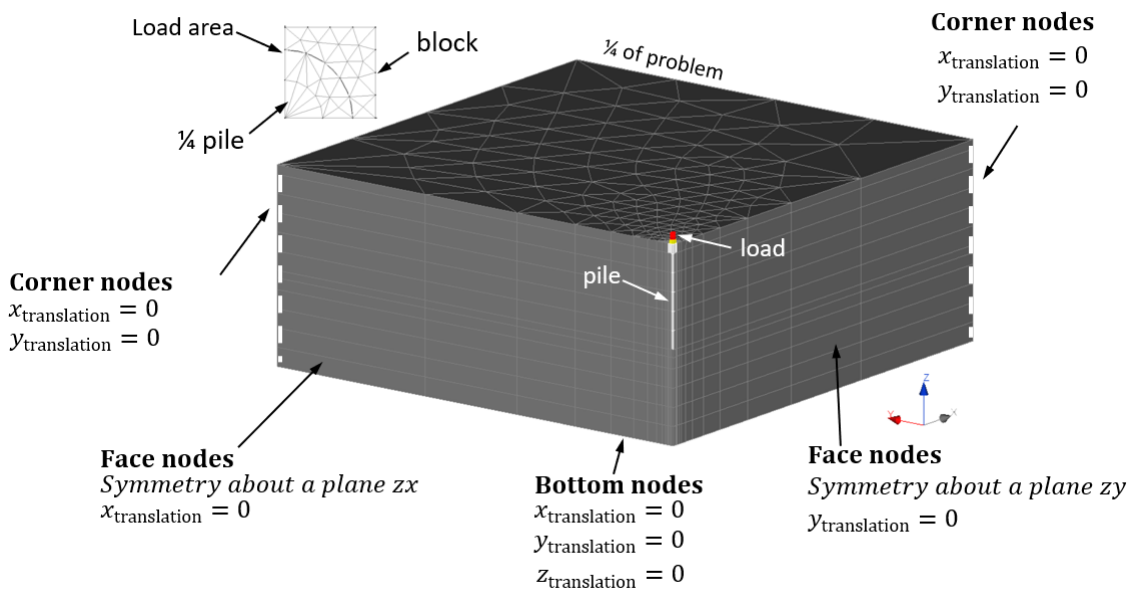
**Figure 2** Boundary conditions of one quarter a symmetric 3D model.

The dimensions of the model and the respective number of nodes and elements were checked. The evaluated geometries were: 30 m x 30 m, 40 m x 40 m and 50 m x 50 m. The boundary conditions imposed to the problem were verified at each simulation of the validation process, in which the boundary conditions of the 50 m x 50 m mesh exhibited maximum deformations less than one tenth of a millimeter, which is considered insignificant for the type of problem under analysis (Figure 2).

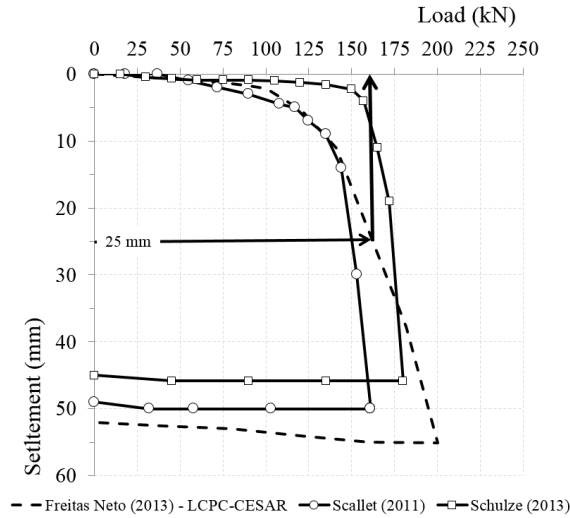
**Figure 3** Numerical and experimental load vs. settlement curves of isolated intact pile (Scallet, 2011; Schulze, 2013; Freitas Neto et al., 2014).

According to Hachich et al. (1998), the ultimate capacity of a foundation can be called a "physical" failure when the relationship between the increment of the pile's settlement and the incremental load tends to approach infinity. Otherwise, such failure is referred to as "conventional", based on a criterion applied when there is no obvious physical failure of the foundation. Various criteria exist for determining the conventional failure load. The criteria proposed by Décourt (1993, 1995), and the British standard (BS 8004:1986, 1986) were adopted in order to determine the conventional ultimate capacity in this study. These criteria indicate that the defined failure load for displacement piles and bored piles must be equivalent to a settlement corresponding to 10% of the nominal pile diameter. In the present paper, the piles had a diameter of 25 cm, thus the defined (geotechnical) ultimate load capacity was equivalent to a settlement of 25 mm ( $= 10\% \times 25$  cm). When applying these criteria to the load vs. settlement curves obtained by Scallet (2011) and Schulze (2013), the defined failure loads were equal to 150 kN and 175 kN, respectively (see Figure 3).

Figure 3 also shows a defined geotechnical ultimate load capacity equivalent to 25 mm settlement obtained from the load vs. settlement curve in the numerical FEM analysis, performed by Freitas Neto (2013), which in this case was equal to approximately 163 kN (Figure 3). Because the loads were reduced along the depth, variation of the axial load along the pile axis (Figure 4) was also determined from the numerical analyses.

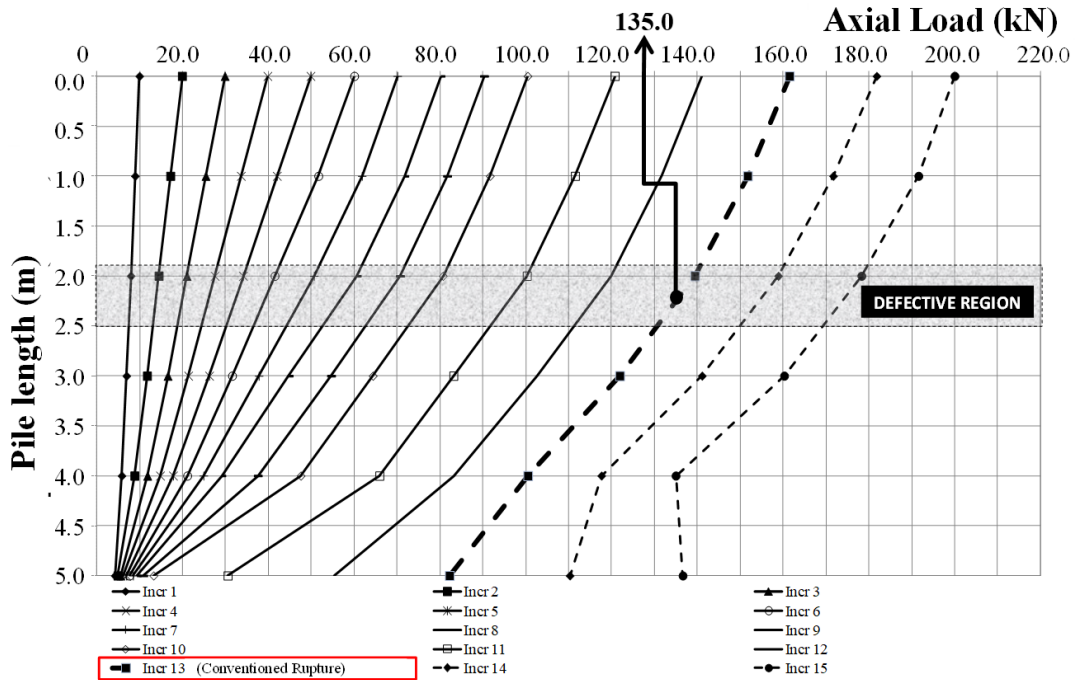
**Figure 4** Numerical prediction of the compressive load along depth on the axis of the simulated isolated pile (Freitas Neto, 2013).

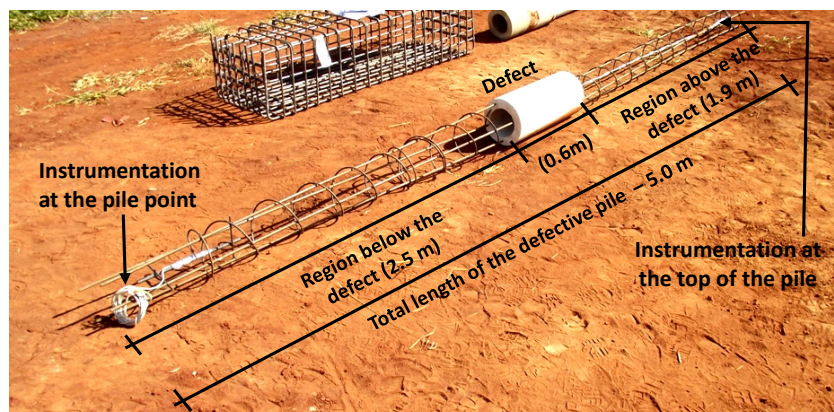
**Figure 6** Longitudinal design of the defective pile (total length, size and positioning of the defective zone and placement of instrumentation).

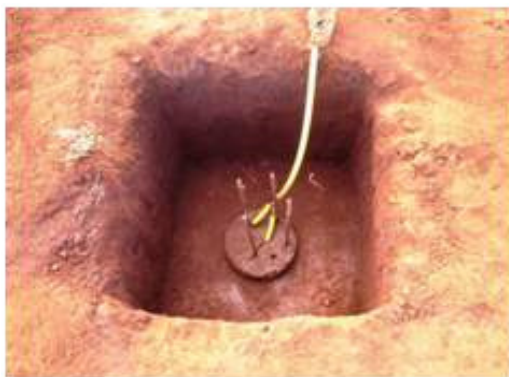
**Figure 7** Excavation to the leveling mark of the pile for  $DPR_{(EXP)}$ .

- (1) Positioning of the reinforcement in the lower region of the pile at the bottom of the borehole;
- (2) Pouring of concrete for the lower 2.5-m-long region of the pile;
- (3) Installation of the pre-molded, hollow mortar cylinder that represented the defective zone, or the defect itself, lowering it until it reached the previously poured region;
- (4) Installation of the upper region of the pile, followed by the pouring of concrete;
- (5) Preparation of the block (pile top block): excavation (Figure 7); positioning of the reinforcement (Figure 8) and concrete casting (Figure 9); and
- (6) Excavation around the block to avoid lateral friction (Figure 10).

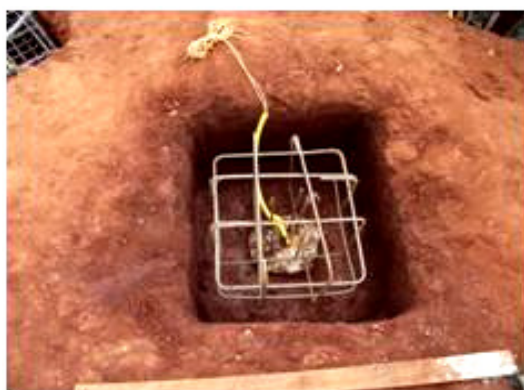
**Figure 8** Positioning the reinforcement for  $DPR_{(EXP)}$ .

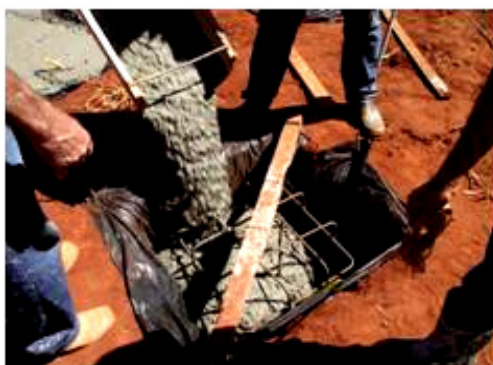
**Figure 9** Pouring the concrete for  $DPR_{(EXP)}$ .

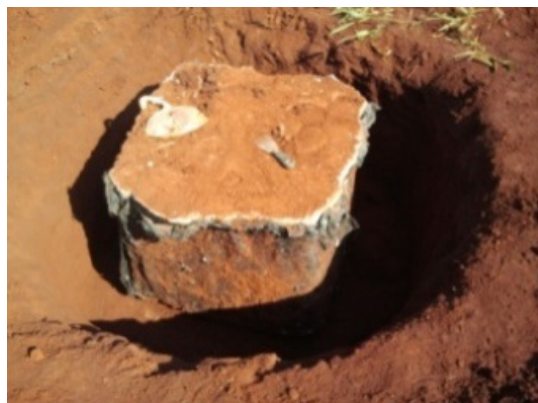
**Figure 10**  $DPR_{(EXP)}$  system excavated laterally.

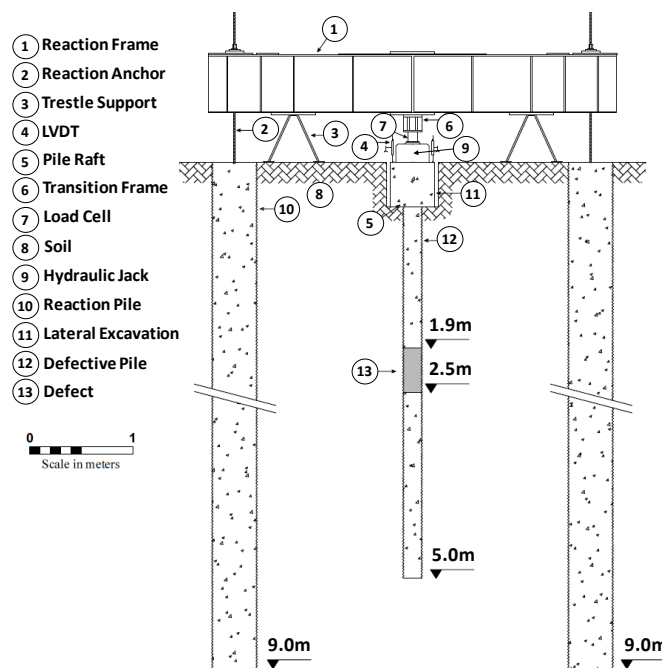
**Figure 11** Front view sketch of the main reaction system (Garcia, 2015).

The load test shown in this study was performed as per the Brazilian standard NBR 12131:2006 (2006). In addition to the test pile, mechanically bored type reaction piles were also installed, with dimensions of 0.6 m × 9.0 m (diameter × length). These piles were designed to resist the tensile forces caused by the reaction system during the load tests and were reinforced with 10 CA-50 steel bars ( $\phi = 10$  mm) and a helical CA-50 steel stirrup ( $\phi = 6.5$  mm). This reinforcement was complemented by the installation of a Dywidag type steel bar with an identical length and diameter of 32 mm. The reaction beam used in the load tests was 5.3 m long and assembled by the union of two I-shaped steel profiles, the cross-section of which had flange and web of 0.32 m and 0.74 m, respectively. It weighed approximately 31 kN and had a resistance capacity of approximately 2,000 kN (Figure 11). An ordinary load cell with the maximum capacity of 2,000 kN was used for the load measurement devices applied to the top of the block. The displacement readings were performed using four displacement transducers (LVDT) with range of 100 mm. These transducers were fixed on two orthogonal axes with magnetic bases and a flexible extensible arm. In this way, it was possible to obtain both the average and the differential settlement on the piled block before and after the structural pile failure (at defective zone).

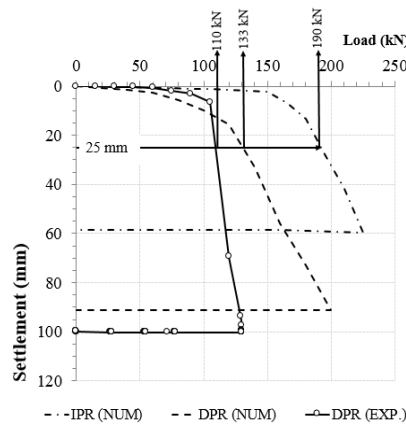
**Figure 12** Comparison of the load vs. settlement curves for the distinct piled blocks either numerically simulated or experimentally tested.

Figure 12 compares the load-settlement curves obtained numerically for the simulated intact and defective piled blocks,  $IPR_{(NUM)}$  and  $DPR_{(NUM)}$ , respectively, together with the experimental data for the defective piled block  $DPR_{(EXP)}$ . Considering only the numerical results, it is hypothesized that a block founded on an intact pile would have a conventional geotechnical failure load of 190 kN. This load was defined as the value corresponding to a 10% displacement of the pile diameter, as mentioned previously. Due to the defective pile, the failure load drops to 133 kN. Taking into account a common definition for safety factor, i.e. the ratio between the ultimate failure load (at intact condition) over the actual load, some interesting scenarios are observed. First, according to the numerical modeling of the defective pile implies an approximately 30% decrease in the pile failure load. Secondly, by developing a defective zone, the defective  $DPR_{(NUM)}$  system geotechnically fails at a safety factor of 1.4 but not 1, as previously expected when applying the (Brazilian) design standard (allowable load at safety factor of 2). It is also noticeable that the value of  $\alpha_{pr}$  during failure, i.e. the division of load between the block and defective pile, was around 0.5 (50%) for both experimental and numerical cases.

Comparing the numerical and experimental results that are respectively valid for the  $IPR_{(NUM)}$  and  $DPR_{(EXP)}$  systems, it can be concluded that there is a decrease of approximately 40% of the failure load of the system foundation. The defective system geotechnically fails at a safety factor of ~1.7 rather than 1. In this latter case, if the system was designed assuming an allowable load of 95 kN at a safety factor of 2 (based on intact  $IPR_{(NUM)}$  failure load), the conclusion is that if a defective zone develops, it leads this system to be at an imminent failure stage (at 110 kN, with an actual safety factor of 1.16).

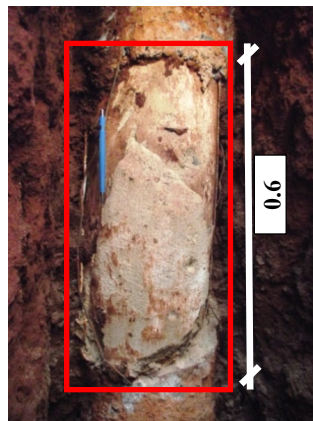
**Figure 13** Defective zone in the pile mobilized after load test performed on  $DPR_{(EXP)}$  system.

To check the structural failure of the pile defective zone, after the load test, a 3 m-deep trench with a 0.9 m diameter was excavated next to the pile. Figures 13 and 14 confirm the structural failure hypothesis and corroborate the predictions (experimental and numerical) for the pile behavior in this particular zone along the testing stages. Indeed, it is noticeable that the defect was fully mobilized, leading to the total failure of this zone. Moreover, by comparing the overall geometric aspects of both failed zones from the laboratory and the field, the failure mechanisms of the defective zone were similar, which was concentrated along one direction of the shaft, perhaps allowing for the extreme angular distortions observed for the tested system in the post failure stage.

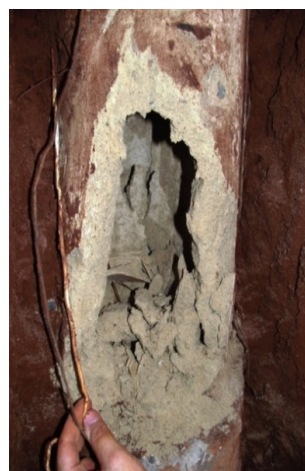
**Figure 14** Another detail of the defect after load tests performed on  $DPR_{(EXP)}$  system.
